Water Quality Plots 2

Replacing what proved to be a troublesome, unreliable monitoring system with another that proved more robust, that helped salvage research, and allowed a successful transition into the new water quality project.

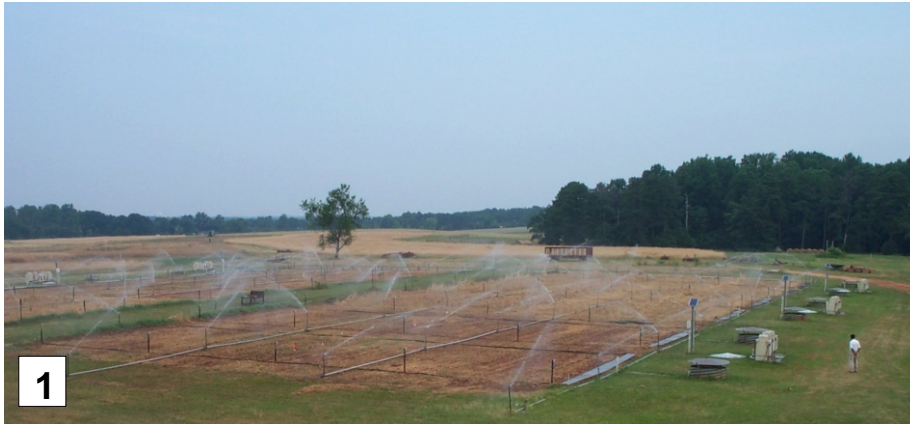
1. Plot layout with irrigation setup which allowed for water quality experiment to proceed during record drought.
2. Soil moisture recording devices were installed in all 12 plots.
3. Original data collection system had 1 datalogger for all plots.
4. New data collection system has 1 datalogger per pair of plots, less confusing, easier calibrations, and less chance of losing data on all plots.
5. Old circuit boards were redesigned and installed.
6. Automated sampler collecting drainage samples.
7. Automated sampler collecting runoff samples.
8. View of irrigation controlled runoff event
9. Water spigots were relocated to flume-end of plots to better facilitate cleaning.
10. Drainage following irrigations on June 4th and 5th, 2002.
